## Case study

# Restoring an iconic World War II torpedo bomber from nothing but wreckage

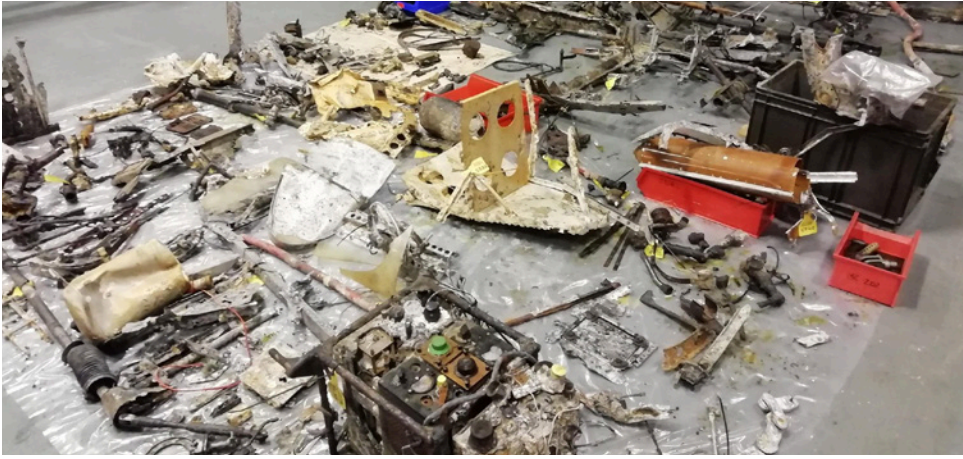
### Fairey Barracuda parts recovered from several different crash sites

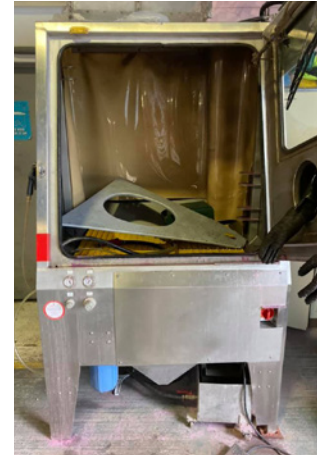
### A large Barracuda component in the Fleet Air Arm Museum's Vapormatt Puma Manual wet blasting machine

Their Vapormatt Puma manual wet blasting machine is helping with the daunting task of recreating a Barracuda to eventually go on display in the museum, and so far the results have been spectacular.
